SERVICE BULLETIN

DATE: April 3, 1998

SUBJECT: ENGINE SURGE/HIGH FUEL DELIVERY/ROTOR WEAR — GM 6.5L APPLICATIONS WITH THE MODEL DS PUMP

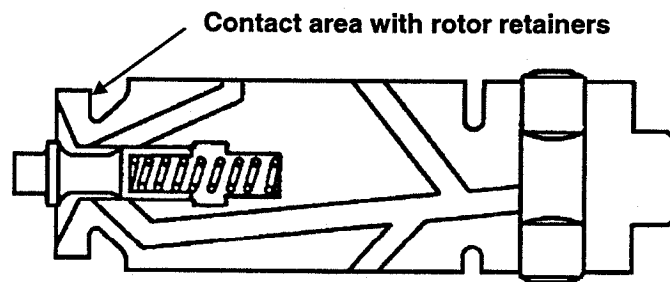
DS Distributor Rotor

General Motors has received a small number of complaints of engine surge on their 6.5L diesel engine equipped with the Model DS pump. These engine surge complaints may be associated with distributor rotor wear in the area where the rotor contacts the rotor retainers as shown in the below illustration. *Note: Other customer complaints associated with rotor wear may include one or more of the following: Black smoke, bucking, rough idle, harsh shifting, and engine over-speed. Also, when rotor wear is the root cause of an engine surge complaint, an "Idle Fuel Rate" of 0-3 mm³/stroke is displayed when checked with a Tech 1 or Tech 2 Diagnostic scan tool.*

Excessive wear in this area of the rotor increases the poppet valve stroke, which subsequently causes fuel delivery to increase beyond specification. Fuel output that exceeds 3.0 mm³/stroke above the specified range at the 3400 ERPM checkpoint (Step 5a of TAR, all DS models) may cause the engine surge condition.

1. Perform the "Test as Received" calibration checks.
2. If fuel delivery is less than 3.0 mm³/stroke over the high end of the specified range at the 3400 ERPM checkpoint (step 5a on all DS models) the pump should be considered "no trouble found" and the pump returned to the customer as is.

If fuel delivery is greater than 3.0 mm³/stroke above the high end of the specification at the 3400 ERPM checkpoint, remove the head and rotor assembly and measure the poppet valve stroke using fixture 31204.

3. If the poppet valve stroke is .008" or greater, replace the head and rotor assembly, reassemble the pump and perform the "Test Following Service" calibration.

If the poppet valve stroke is less than .008", reset the poppet valve stroke, reassemble the pump and perform the "Test Following Service" calibration. **Do not replace the head and rotor assembly when the poppet valve stroke is between .005 - .008".**
