SERVICE BULLETIN

DATE: August 14, 1998

SUBJECT: NEW PUMP MODEL FOR 1999 MODEL YEAR GM 6.5L DIESEL

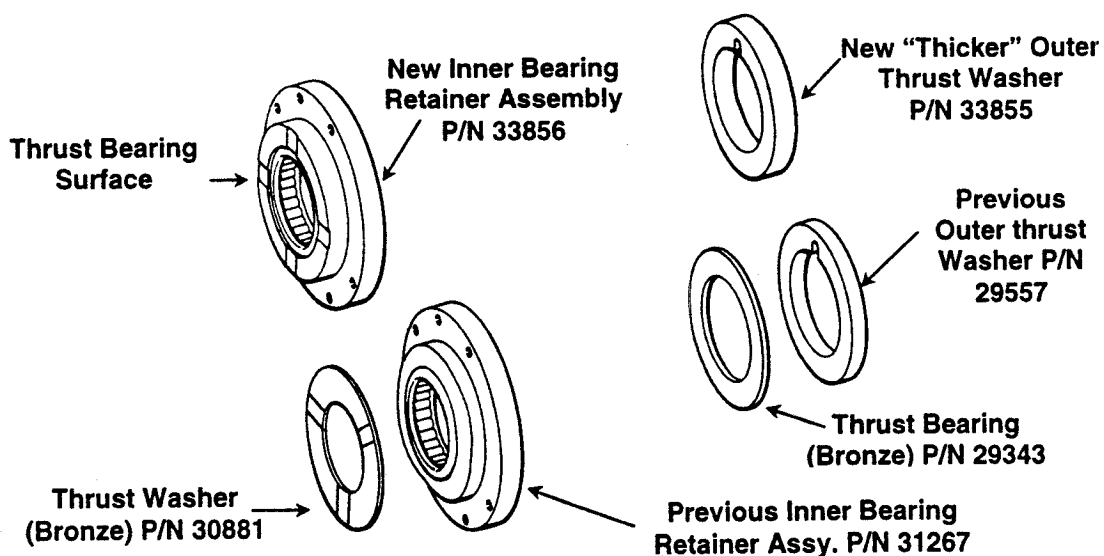
Figure 1

The bronze thrust bearings used in the DS pump drive shaft/transfer pump group have been eliminated. A new thicker inner bearing retainer assembly, P/N 33856, has been released. It incorporates the axial thrust bearing surface and supersedes the previously used 31267 inner bearing retainer. At the other end of the drive shaft/transfer pump group is a new thicker thrust washer, P/N 33855. It supersedes the previous 29557 washer and 29343 bronze thrust bearing. The previous and new configurations are as shown in Figure 1.

1. If a 31267 inner bearing retainer assembly requires replacement, discard it and the 30881 thrust bearing and replace it with the 33856 inner bearing retainer assembly.
2. The 30881 will continue to be available for service. Therefore, if only a 30881 thrust bearing requires replacement, you may replace the thrust bearing and reuse the previous 31267 inner bearing retainer assembly.
3. If the 29557 outer thrust washer and/or the 29343 bronze thrust bearing require replacement, discard both parts and replace them with the current 33855 outer thrust washer.

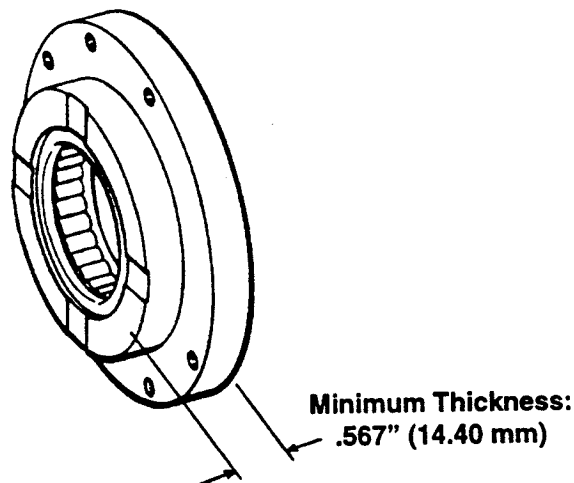
Figure 2

Minor scoring and polishing on the axial thrust face of the new 33856 inner bearing assembly is considered normal. The 33856 should only be replaced during service when the thickness of the assembly is less than 0.567 inches (14.40 mm) as shown in Figure 2.
